DEPARTMENT OF TRANSPORTATION**DIVISION OF ENGINEERING SERVICES**

Contract #: 04-0120F4Cty: SF/ALA Rte: 80 PM: 13.2/13.9File #: 69.28**WELDING INSPECTION REPORT****Resident Engineer:**Pursell, Gary**Address:** 333 Burma Road**City:** Oakland, CA 94607**Report No:** WIR-004698**Date Inspected:** 17-Nov-2008**Project Name:** SAS Superstructure**OSM Arrival Time:** 630**Prime Contractor:** American Bridge/Fluor Enterprises, a JV**OSM Departure Time:** 1530**Contractor:** Zhenhua Port Machinery Company, Ltd (ZPMC), Changxing Island **Location:** Shanghai, China**CWI Name:** Sun Wei**CWI Present:** Yes No**Inspected CWI report:** Yes No N/A**Rod Oven in Use:** Yes No N/A**Electrode to specification:** Yes No N/A**Weld Procedures Followed:** Yes No N/A**Qualified Welders:** Yes No N/A**Verified Joint Fit-up:** Yes No N/A**Approved Drawings:** Yes No N/A**Approved WPS:** Yes No N/A**Delayed / Cancelled:** Yes No N/A**Bridge No:** 34-0006**Component:** Tower & OBG**Summary of Items Observed:**

WELDING INSPECTION REPORT

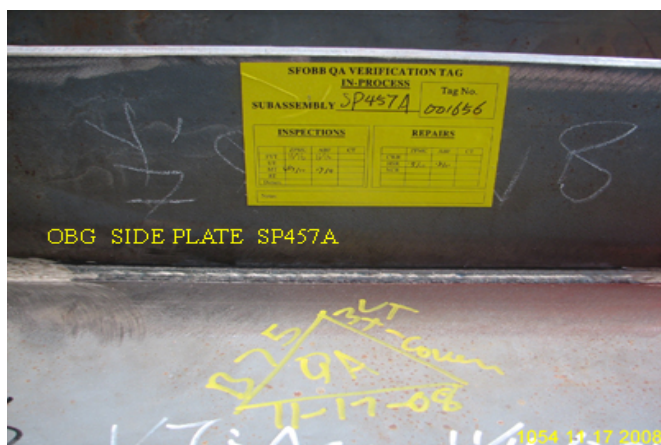
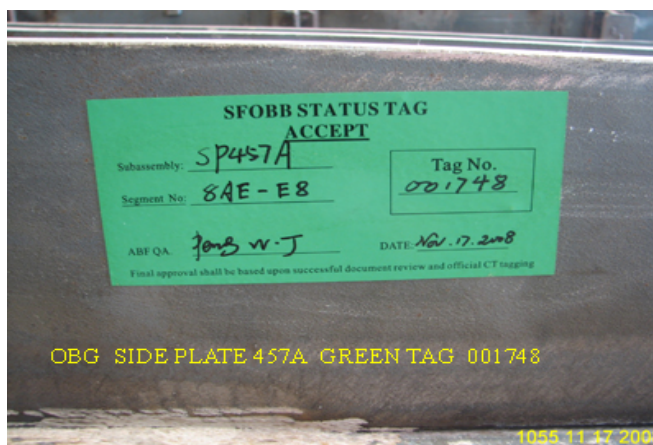
The QA Inspector randomly observed ZPMC Non-Destructive Testing (NDT) Technician Bo Tin Rui, utilizing the Magnetic Particle Testing (MT) Method to perform a final MT examination of the cover pass of the fillet welds on Side Plate Sub-Assemblies SP445A/Yellow Tag 001653 WJ's 001 through 010, SP446A/Yellow Tag 001655 WJ's 001 through 010, SP457A/Yellow Tag 001656 WJ's 001 through 010 and SP621A/Yellow Tag 001654 WJ's 025 through 026 and 055 through 066. There appeared to be no indications and ZPMC QC accepted all welds on the above listed Side Plates.

The QA Inspector performed a 10% final Visual (VT) and MT verification on the cover pass of the fillet welds on Side Plate Sub-Assemblies SP445A/Yellow Tag 001653 - SP445-001 WJ's 001 through 010(Green Tag 001746), SP446A/Yellow Tag 001655 WJ's 001 through 010(Green Tag 001749), SP457A/Yellow Tag 001656 WJ's 001 through 010(Green Tag 001749) and SP621A/Yellow Tag 001654 WJ's 025 through 036 and 055 through 066 (Green Tag 001749). There appeared to be no indications the QA Inspector accepted all welds on the above listed Side Plates. The attached photographs provide additional detail.
